T-386
Cottingham Farm Orchard Buildings
Goldsborough Neck Road
Easton Vicinity
Ca. 1929-1939
Private

# Maryland Historical Trust Maryland Inventory of Historic Properties Form

1. Name of Pr	operty				*
historic	Cottingh	nam Farm Orchard Building	IS		7
other	New Ho	use Orchard Buildings			
2. Location	(288	56 Goldsborough	NeckRd Pr	remises Ad	ldress)
street and number	Goldsbo	rough Neck Road		N/A	not for publication
city, town	Easton			_ X	vicinity
county	Talbot

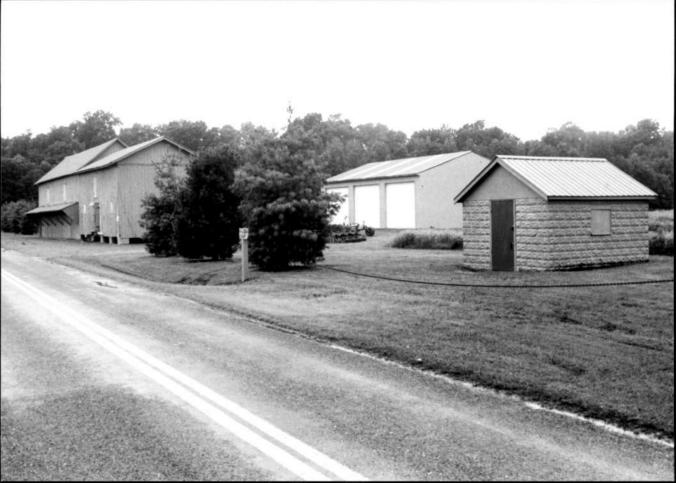
T- 386 Osthyrham Farm Talbot Co. MD M. Edwards 8/7/03 MD SHIO Shed + Storage bldg. Lok NW ( From Road

The main building of the complex is the picker's shed, built ca. 1935. The shed is a two-story timber frame structure with a poured concrete pier foundation. The building is six bays deep with a hayloft on the second level. The side gable roof is clad with corrugated standing-seam metal and has hay hoods on either end.

The one-and-a-half story storage building is connected to the picker's shed on the east façade. The storage building rests on a brick pier foundation. The building is clad with vertical wood boards. The side gable roof is clad with corrugated standing-seam metal. The interior is accessed via a hinged wood plank door located three-feet above ground level on the south façade. The loading dock has been removed from the south façade, but its outline remains.

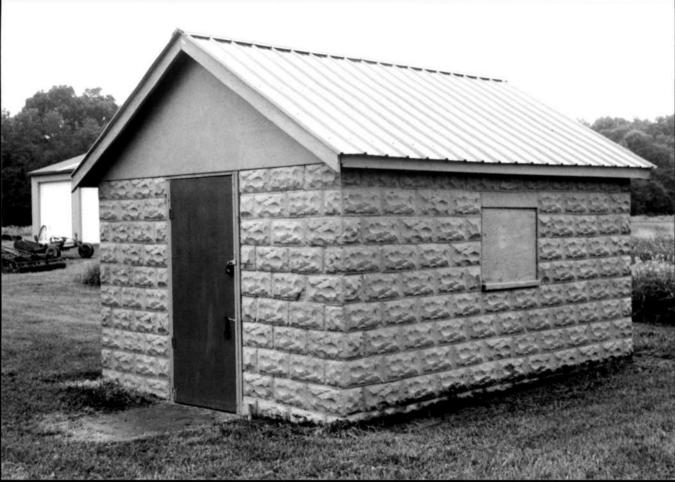
T-386 Cottingham Farm Talbot Co MD M. Edwards 8/1/03 Storage shed face concrete Looy NW

The shed, constructed ca. 1935, is a one-story masonry structure. The building rests on a poured concrete slab and is constructed of rusticated, rock-faced concrete masonry units. Plywood sheeting is used to infill the gable ends. The front-gable roof is clad with corrugated standing-seam metal. The building is entered through a hinged wood plank door on the south façade. One rectangular window opening, since boarded up, is located on each remaining façade. A poured concrete slab approximately three-feet by three-feet is located outside the entry door. The interior was not accessible at the time of the survey.
